**Flood Control Project Maintenance
Levee Inspections**

Fall 2016 Levee Maintenance Deficiency Summary Report

Reclamation District No. 0349 Sutter Island

Fall 2016 Levee Inspection Results

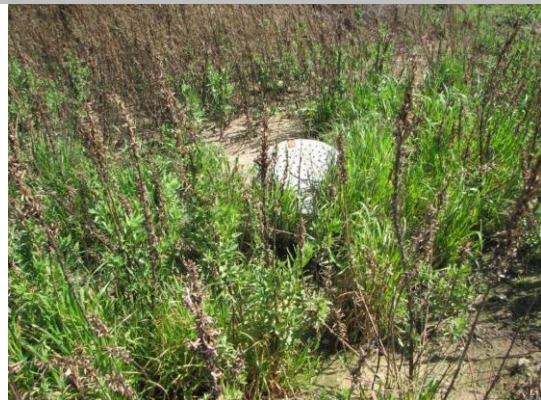
Photo 2 of 2 : UCIP_FA_2016_47045_36735.jpg

Comment Code					
Inspector Comment					
FS_ID:47045					
DS_ID:24172					
EP_NO: N/A					
Repair Type: Non-Urgent					
Crossing Status: Found					
UCIP Comments: Dense vegetation limits the inspector's visibility to identify signs of pipe failure (leaks) through the levee slopes.					
Recommend removing vegetation along pipe alignment to conduct proper inspection of structure and appurtenances. Note date on photos should be 3/18/09 not 7/26/08 camera metadata is incorrect.					
FIELD_STRUCT_DESC: 1 of 2: 12-inch pipe and 2-inch electrical conduit through the levee, both 8.0 feet below the crown. Siphon breaker in pipe riser on landward slope. Concrete standpipe at landward toe. Pump on waterward side with stairway access.					
FS Date: 3/19/2009

Stand pipe located on landward shoulder--pipe locked.

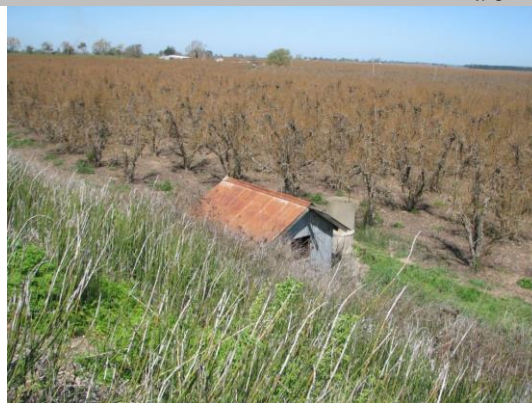
Photo 1 of 2 : UCIP_FA_2016_21634_36739.jpg

Comment Code					
Inspector Comment					
FS_ID:21634 DS_ID:24173 EP_NO: N/A Repair Type: Non-Urgent Crossing Status: Found UCIP Comments: Dense vegetation limits the inspector's visibility to identify signs of pipe failure (leaks) through the levee slopes. Recommend removing vegetation along pipe alignment to conduct proper inspection of structure and appurtenances. Note date on photos should be 3/18/09 not 7/26/08 camera metadata is incorrect. FIELD_STRUCT_DESC: 8-inch pipe through the levee, 6.7 feet below the crown. Pump in pumphouse and concrete standpipe at the landward toe. (USACE-1959). This entry matches the Drainage or Irrigation Structure referenced in O&M manual (HLM 2.1). FS Date: 3/19/2009

View of landward side--pump house and stand pipe.

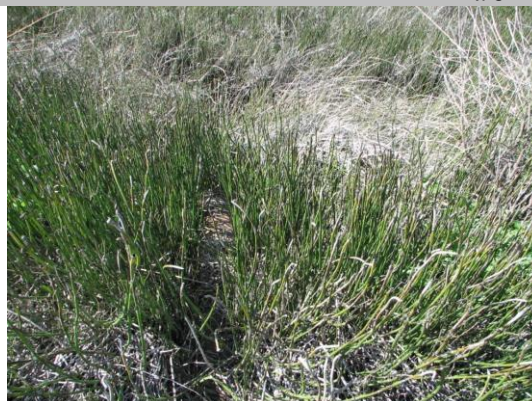
Photo 1 of 2 : UCIP_FA_2016_43423_36866.jpg

FS_ID:43423
DS_ID:24176
EP_NO: N/A
Repair Type: Non-Urgent
Crossing Status: Found
UCIP Comments: Need to contact owner--If crossing is no longer used by owner, the owner will need to coordinate with DWR Inspector and CVFPB to remove crossing according to Title 23 requirements. Dense vegetation limits the inspector's visibility to identify signs of pipe failure (leaks) through the levee slopes. Recommend removing vegetation along pipe alignment to conduct proper inspection of structure and appurtenances. Note date on photos should be 3/18/09 not 7/26/08 camera metadata is incorrect.
FIELD_STRUCT_DESC: *ABANDONED* 10-inch pipe through the levee, 8.2 feet below the crown. Pipe has plate welded on the waterward end. 3-inch galvanized pipe runs parallel to 10-inch pipe. Abandoned tank on waterward slope. Distribution box and concrete standpipe at landward toe. (USACE-1959). This entry matches the Drainage or Irrigation Structure referenced in O&M manual (HLM 2.7).

View of waterward side--dense vegetation covers slope.

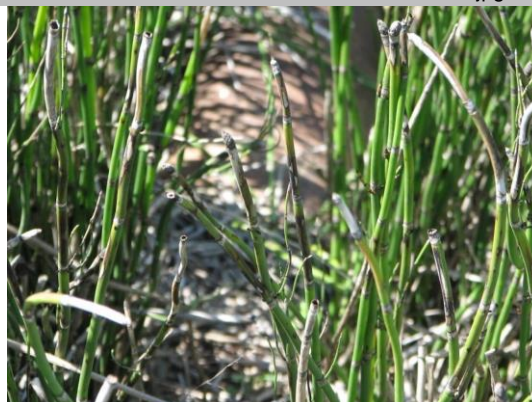
Photo 2 of 2 : UCIP_FA_2016_43423_36865.jpg

Pipe visible on waterward side.

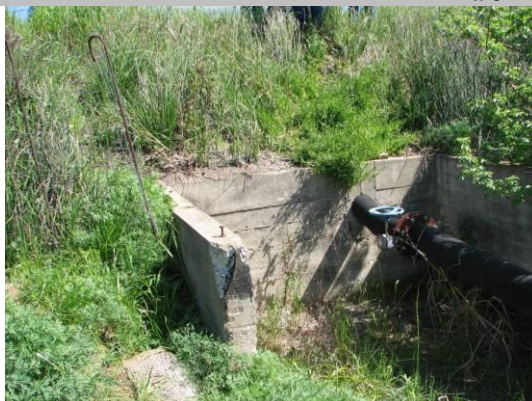
Photo 2 of 2 : UCIP_FA_2016_43424_36871.jpg

Item	DWR UCIP Field Study			38.292557 °	38.292557 °	
				-121.603767 °	-121.603767 °	
DWR ID						
Comment Code						
Inspector Comment						
FS_ID:43424 DS_ID:24177 EP_NO: N/A Repair Type: Non-Urgent Crossing Status: Found UCIP Comments: 2007 Erosion Repair Site location?--Need to contact owner to determine if crossing is still in use. If crossing is no longer used by owner, the owner will need to coordinate with DWR Inspector and CVFPB to remove crossing according to Title 23 requirements. Dense vegetation limits the inspector's visibility to identify signs of pipe failure (leaks) through the levee slopes. Recommend removing vegetation along pipe alignment to conduct proper inspection of structure and appurtenances. Note date on photos should be 3/18/09 not 7/26/08 camera metadata is incorrect. FIELD_STRUCT_DESC: *ABANDONED* 8-inch pipe through the levee, 8.7 feet below the crown. Headwall and gate valve on the landward side. FS Date: 3/19/2009

View of waterward side--headwall, pipe, and gate valve.

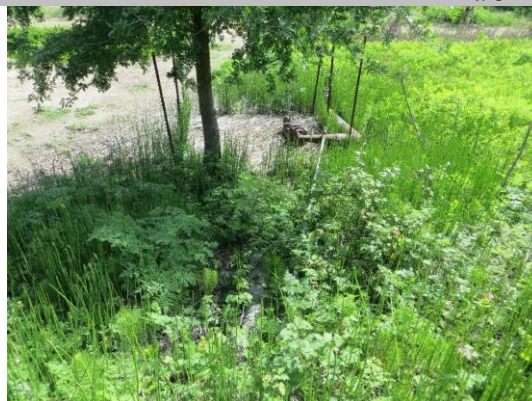
Photo 1 of 2 : UCIP_FA_2016_50014_73743.jpg

FS_ID:50014
DS_ID:24178
EP_NO: 6321
Repair Type: Urgent
Crossing Status: Found
UCIP Comments: 8/17/2016 Unable to determine condition of crossing due to dense vegetation on both WS and LS. Need to contact owner to determine status of crossing. Unable to confirm if WS pipe capped with metal plate. (DWR UCIP - omagana)4/08/2015 Appears abandoned and if so should be done so properly. Pipe open at LS toe. Unable to verify if plate is welded over WS end. (DWR UCIP - omagana)
FIELD_STRUCT_DESC: *ABANDONED* 8-inch steel irrigation pipe through the levee, 4.5 feet below the crown. Corrugated metal cutoff wall around pipe at center of levee. Siphon breaker is located on the waterside (WS) shoulder. Pump is located on the landside (LS). Gate valve is located on the WS. 1.5-inch filler pipe at same location. Plate welded to WS end (Permit No. 6321, 1969 - B.C. Wheeler).
FS Date: 8/17/2016

Pipe and pump platform on LS toe.

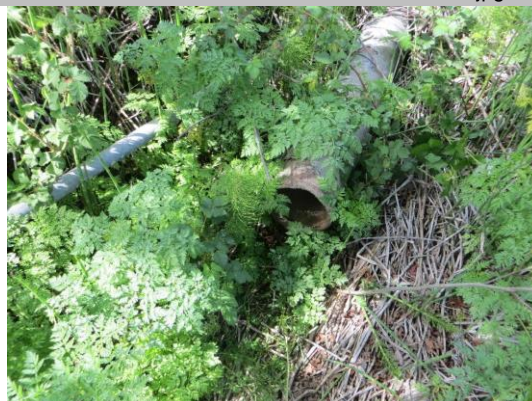
Photo 2 of 2 : UCIP_FA_2016_50014_73742.jpg

1.5-inch filler pipe and 8-inch steel irrigation pipe at LS toe.

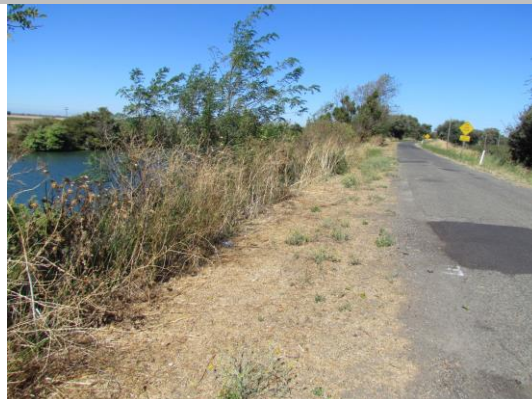
Photo 1 of 1 : FA_2016_RD0349_206_41_20161017_00074.jpg

LM Start	3.02	Rating **	U	Issue No.	41
LM End	6.31	Issue Type +	Ma	Location *	WS
Category	Earthen Levee			GPS Latitude/Longitude	
				Start	End
Item	Vegetation			38.296065 °	38.329043 °
				-121.604718 °	-121.579382 °
DWR ID	DWR_RD0349_03_f_2016_41				
Comment Code					
V1 : Control annual grass and weeds on the levee slopes and easements.					
Inspector Comment					
From levee mile 3.02 to levee mile 6.31 water side slope is overgrown with tall weeds and other wild vegetation.

RD 349 Unit 3 levee mile 3.02 looking downstream waterside.

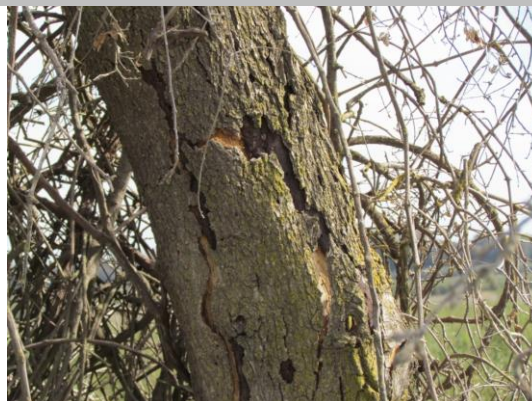
Photo 1 of 2 : FA_2016_RD0349_206_73_20160913_00004.jpg

LM Start	3.19	Rating **	U	Issue No.	73
LM End	3.19	Issue Type +	Ma	Location *	LS
Category	Earthen Levee			GPS Latitude/Longitude	
				Start	End
Item	Trim / Thin Trees			38.298223 °	38.298223 °
				-121.603240 °	-121.603240 °
DWR ID	DWR_RD0349_03_f_2014_73				
Comment Code					
T4 : Trim trees over roadway to at least 12 feet above ground level.					
Inspector Comment					
This tree on the landside slope is rotten and could possibly fall across levee section.

Close up view of dead tree standing above crown roadway.

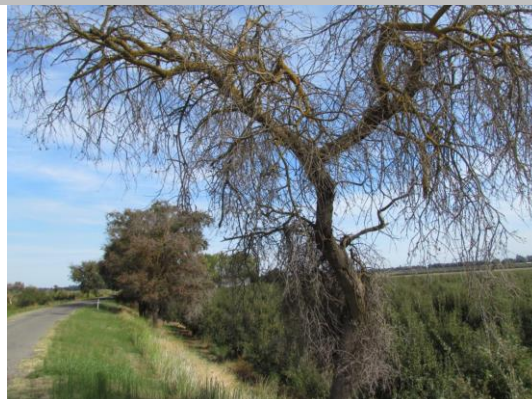
Photo 2 of 2 : FA_2016_RD0349_206_73_20160913_00005.jpg

Dead tree above crown roadway landward.

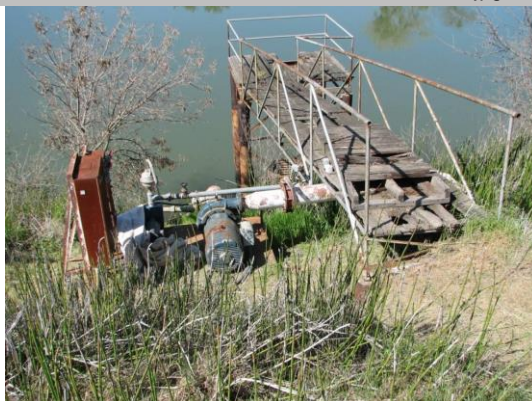
Photo 1 of 2 : UCIP_FA_2016_44389_36873.jpg

LM Start	3.34	Rating **	M	Issue No.	993
LM End	3.34	Issue Type +	En	Location *	LS
Category	Supplemental			GPS Latitude/Longitude	
				Start	End
Item	DWR UCIP Field Study			38.299703 °	38.299703 °
				-121.601112 °	-121.601112 °
DWR ID					
Comment Code					
Inspector Comment					
FS_ID:44389 DS_ID:24179 EP_NO: N/A Repair Type: Non-Urgent Crossing Status: Found UCIP Comments: Crossing altered--need to contact owner to obtain permit number authorizing work. Dense vegetation limits the inspector's visibility to identify signs of pipe failure (leaks) along the slope. Recommend removing vegetation along pipe alignment to conduct proper inspection of structure and appurtenances. Note date on photos should be 3/18/09 not 7/26/08 camera metadata is incorrect. FIELD_STRUCT_DESC: *DELETE* FS Date: 4/9/2015

View of waterward side--pump, control panel, pipe, and walkway.

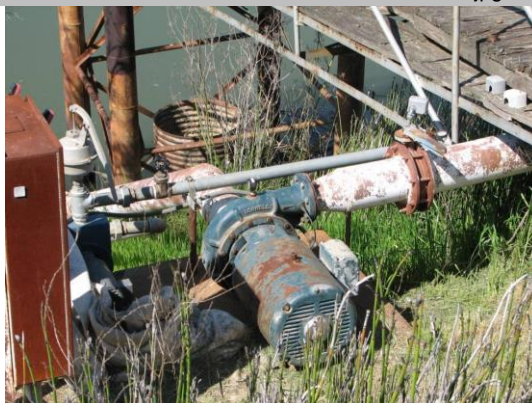
Photo 2 of 2 : UCIP_FA_2016_44389_36875.jpg

Corrugated metal riser located on waterward toe.

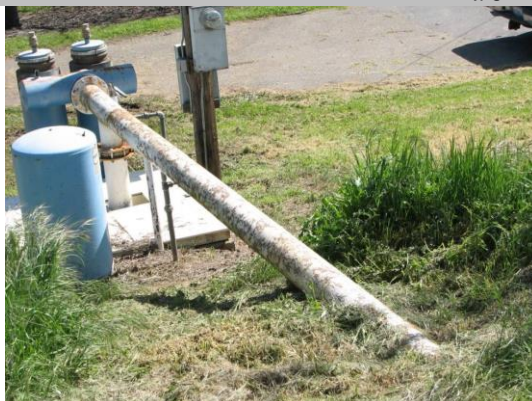
Photo 1 of 2 : UCIP_FA_2016_44390_73745.jpg

LM Start	3.34	Rating **	M	Issue No.	994
LM End	3.34	Issue Type +	En	Location *	LS
Category	Supplemental			GPS Latitude/Longitude	
				Start	End
Item	DWR UCIP Field Study			38.299718 °	38.299718 °
				-121.601095 °	-121.601095 °
DWR ID					
Comment Code					
Inspector Comment					
FS_ID:44390					
DS_ID:24214					
EP_NO: N/A					
Repair Type: Non-Urgent					
Crossing Status: Found					
UCIP Comments: Walway and pier abandoned and appears to be a hazard that should be removed.					
FIELD_STRUCT_DESC: 10-inch steel irrigation pipe through the levee 5.8-feet below the crown. Pump, butterfly valve, and electrical panel on WS slope. Pier and walkway next to pump on WS slope. Power pole, filters, and distribution box at LS toe.					
FS Date: 4/9/2015

Pipe, filter system, powerpole, and distribution box at LS toe.

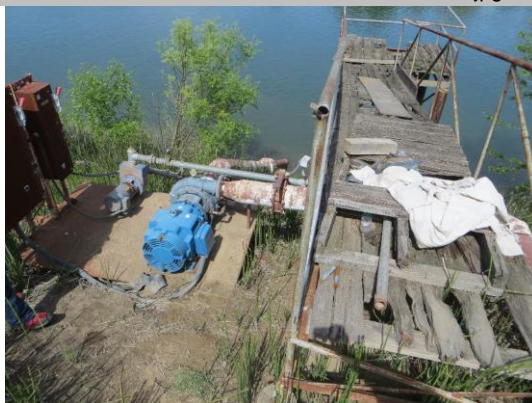
Photo 2 of 2 : UCIP_FA_2016_44390_73746.jpg

Pump, electrical panel, butterfly valve, and walkway on WS slope.

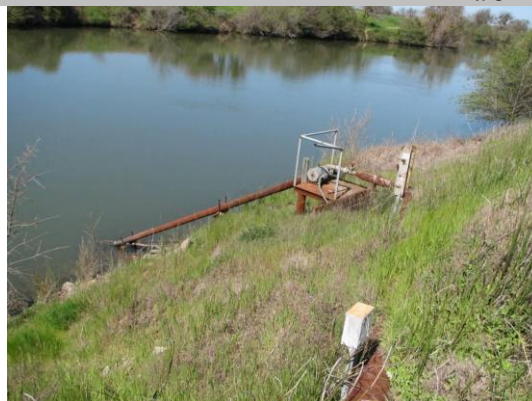
Photo 1 of 2 : UCIP_FA_2016_21644_36780.jpg

Comment Code					
Inspector Comment					
FS_ID:21644 DS_ID:24180 EP_NO: 9290 Repair Type: Non-Urgent Crossing Status: Found UCIP Comments: Dense vegetation limits the inspector's visibility to identify signs of pipe failure (leaks) through the levee slopes. Recommend removing vegetation along pipe alignment to conduct proper inspection of structure and appurtenances. FIELD_STRUCT_DESC: 10-inch steel pipe and 1.5-inch steel electrical conduit through the levee, both 4.0 feet below the crown. Steel cutoff wall around pipe and conduit at center of levee. Pump and gate valve on waterward slope. 6-inch intake pipe extends from pump into channel. Distribution system at landward toe. (Permit No. 9290-1975) FS Date: 3/19/2009

View of waterward side.

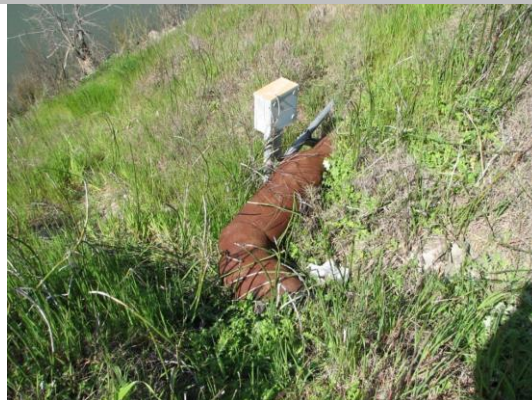
Photo 2 of 2 : UCIP_FA_2016_21644_36778.jpg

90 elbow at daylight and continues along slope and connects to pump.

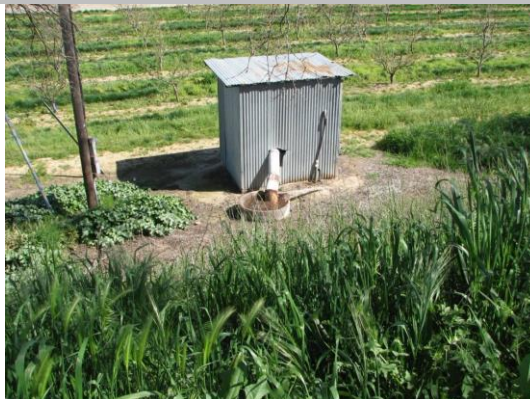
Photo 1 of 2 : UCIP_FA_2016_43455_36783.jpg

FS_ID:43455
DS_ID:24201
EP_NO: 15503
Repair Type: Non-Urgent
Crossing Status: Found
UCIP Comments: Dense vegetation limits the inspector's visibility to identify signs of pipe failure (leaks) through the levee slopes. Recommend removing vegetation along pipe alignment to conduct proper inspection of structure and appurtenances. Note date on photos should be 3/18/09 not 7/26/08 camera metadata is incorrect.
FIELD_STRUCT_DESC: 10-inch steel irrigation pipe through the levee, 3.0 feet below the crown. Steel cutoff wall around pipe 24-inches landward of levee center. Pump and gate valve in pumphouse at the landward toe. Pipe is exposed along waterward slope. (Permit No. 15503-1990)
FS Date: 3/19/2009

Pump house located on landward side.

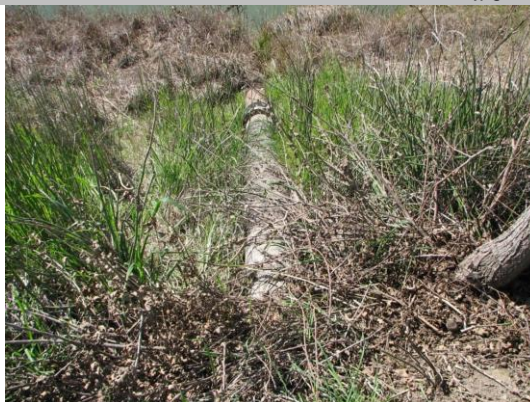
Photo 2 of 2 : UCIP_FA_2016_43455_36782.jpg

View of waterward side.

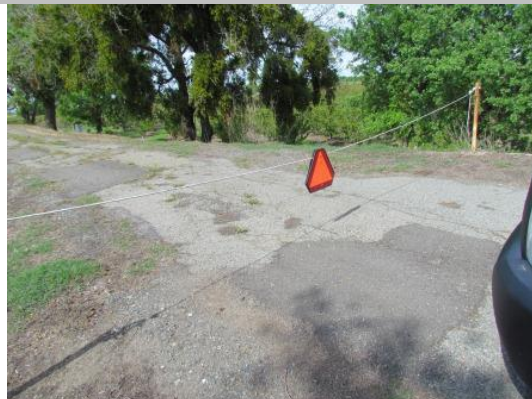
Photo 1 of 1 : FA_2016_RD0349_206_25_20160913_00001.jpg

LM Start	3.99	Rating **	U	Issue No.	25
LM End	3.99	Issue Type +	En	Location *	LS
Category	Earthen Levee			GPS Latitude/Longitude	
				Start	End
Item	Encroachments			38.307997 °	38.307997 °
				-121.597039 °	-121.597039 °
DWR ID	DWR_RD0349_03_s_2012_25				
Comment Code					
FE : Fence					
Inspector Comment					
Unauthorized cable gate crossing levee. Cable gates crossing the levee crown have been prohibited. There is no CVFPB permit for this crossing. This encroachment should be removed.

Cable crossings has been banned. They are unauthorized. No new photo.

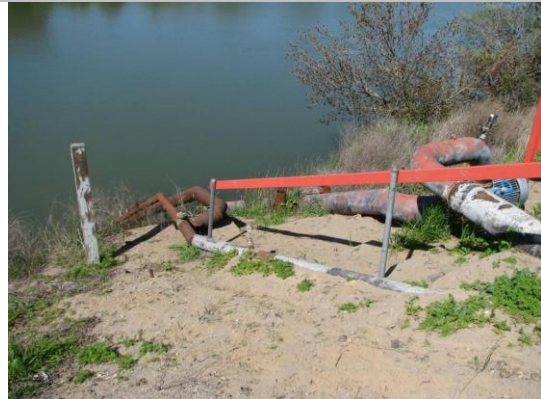
Photo 1 of 1 : UCIP_FA_2016_43458_36784.jpg

Comment Code					
Inspector Comment					
FS_ID:43458 DS_ID:24183 EP_NO: 8681 Repair Type: Non-Urgent Crossing Status: Found UCIP Comments: Need to contact owner to determine status of crossing. If crossing is no longer in use owner will need to coordinate with DWR inspector and CVFPB to remove according to Title 23 requirements. Dense vegetation limits the inspector's visibility to identify signs of pipe failure (leaks) through the levee slopes. Recommend removing vegetation along pipe alignment to conduct proper inspection of structure and appurtenances. Note date on photos should be 3/18/09 not 7/26/08 camera metadata is incorrect. FIELD_STRUCT_DESC: 1 of 2: 6-inch steel pipe and 1.5-inch steel electrical conduit through the levee, 4.1 feet and 2.0 feet below the crown, respectively. Steel cutoff wall around pipe and conduit at center of levee. Pump on platform and gate valve on the waterward slope, not connected. Exposed suction pipe from pump to channel. Rock revetment on waterward slope. (Permit No. 8681-1973) FS Date: 3/19/2009

View of waterward side. 2 crossing visible 12-inch and 6-inch pipes.

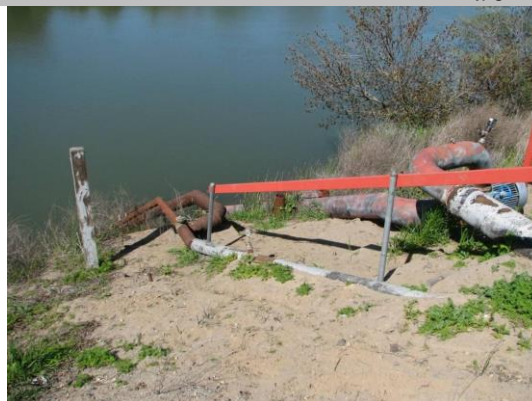
Photo 1 of 2 : UCIP_FA_2016_43457_36793.jpg

FS_ID:43457
DS_ID:24184
EP_NO: 8681
Repair Type: Non-Urgent
Crossing Status: Found
UCIP Comments: Need to contact owner. Is filter sytem located on landward side part of crossing. If so need permit number authorizing work. Also if crossing is no longer used by owner, the owner will need to coordinate with DWR Inspector and CVFPB to remove crossing according to Title 23 requirements. Dense vegetation limits the inspector's visibility to identify signs of pipe failure (leaks) through the levee slopes. Recommend removing vegetation along pipe alignment to conduct proper inspection of structure and appurtenances. Note date on photos should be 3/18/09 not 7/26/08 camera metadata is incorrect. FIELD_STRUCT_DESC: 2 of 2: 12-inch steel irrigation pipe through the levee, 4.3 feet below the crown. Steel cutoff wall around pipe at center of levee. Pump on platform and gate valve on the waterward slope. Exposed suction pipe from pump to channel. Rock revetment on waterward slope. (Permit No. 8681-1973)

View of waterward side. 2 crossing visible 12-inch and 6-inch pipes.

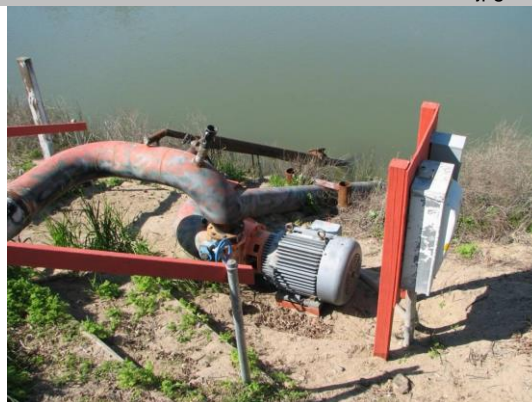
Photo 2 of 2 : UCIP_FA_2016_43457_36792.jpg

Pump associated with 12-inch pipe.

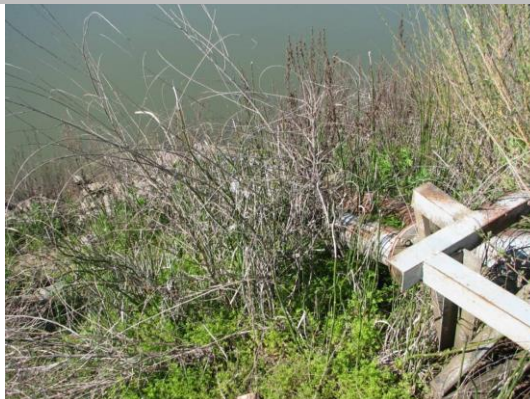
Photo 1 of 2 : UCIP_FA_2016_43459_36796.jpg

FS_ID:43459
DS_ID:24185
EP_NO: N/A
Repair Type: Non-Urgent
Crossing Status: Found
UCIP Comments: No connection present--need to contact owner to determine if owner plans to use. If crossing is no longer in use owner will need to coordinate with DWR inspector and CVFPB to remove according to Title 23 requirements. Recommend removing vegetation along pipe alignment. Note date on photos should be 3/18/09 not 7/26/08 camera metadata is incorrect.
FIELD_STRUCT_DESC: *ABANDONED* 10-inch steel irrigation pipe and 2-inch electrical conduit through the levee, both 2.8 feet below the crown. Abandoned pumps and gate valve on the waterward slope. Service pole on the landward slope. Concrete headwall on landward side. (USACE-1959). This entry matches the Drainage or Irrigation Structure referenced in O&M manual (HLM 4.8).
FS Date: 3/19/2009

Waterward side--pipe visible through dense vegetation.

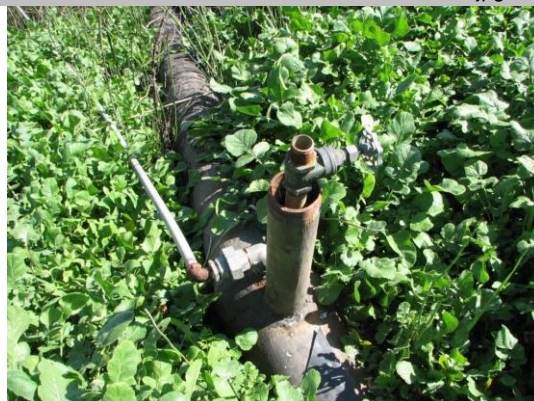
Photo 1 of 2 : UCIP_FA_2016_43431_36800.jpg

Comment Code					
Inspector Comment					
FS_ID:43431 DS_ID:24186 EP_NO: 15359 Repair Type: Non-Urgent Crossing Status: Found UCIP Comments: Dense vegetation limits the inspector's visibility to identify signs of pipe failure (leaks) through the levee slopes. Recommend removing vegetation along pipe alignment to conduct proper inspection of structure and appurtenances. Note date on photos should be 3/18/09 not 7/26/08 camera metadata is incorrect. FIELD_STRUCT_DESC: 10-inch steel irrigation pipe through the levee, 6.0 feet below the crown. Siphon breaker in protective house at levee shoulder. Pump in pumphouse and power pole at landward toe. Pipe connected to 8-inch exposed pipe at landward shoulder, extending to pumphouse. Filter screen in channel at waterward toe. (Permit No. 15359-1990) FS Date: 3/19/2009

Air vent located on pipe on landward.

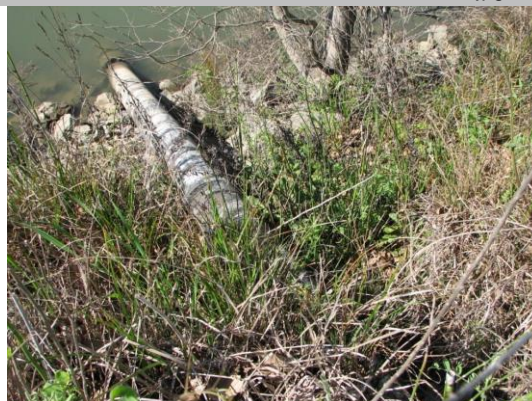
Photo 2 of 2 : UCIP_FA_2016_43431_36801.jpg

Comment Code					
Inspector Comment					
FS_ID:43431 DS_ID:24186 EP_NO: 15359 Repair Type: Non-Urgent Crossing Status: Found UCIP Comments: Dense vegetation limits the inspector's visibility to identify signs of pipe failure (leaks) through the levee slopes. Recommend removing vegetation along pipe alignment to conduct proper inspection of structure and appurtenances. Note date on photos should be 3/18/09 not 7/26/08 camera metadata is incorrect. FIELD_STRUCT_DESC: 10-inch steel irrigation pipe through the levee, 6.0 feet below the crown. Siphon breaker in protective house at levee shoulder. Pump in pumphouse and power pole at landward toe. Pipe connected to 8-inch exposed pipe at landward shoulder, extending to pumphouse. Filter screen in channel at waterward toe. (Permit No. 15359-1990) FS Date: 3/19/2009

Pipe located on waterward side.

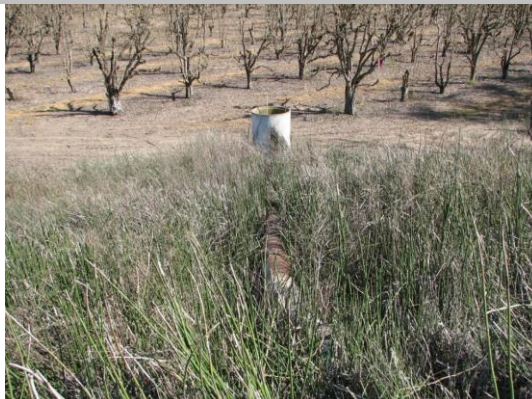
Photo 1 of 2 : UCIP_FA_2016_43433_70484.jpg

FS_ID:43433
DS_ID:24188
EP_NO: N/A
Repair Type: Non-Urgent
Crossing Status: Found
UCIP Comments: Walkway is no longer functional. Need to contact owner--if crossing is no longer used owner will need to coordinate with DWR Inspector and CVFPB. Dense vegetation limits the inspector's visibility to identify signs of pipe failure (leaks) through the levee slopes. Recommend removing vegetation along pipe alignment to conduct proper inspection of structure and appurtenances. Note date on photos should be 3/18/09 not 7/26/08 camera metadata is incorrect.
FIELD_STRUCT_DESC: 12-inch pipe through the levee, 6.2 feet below the crown. Pump and control panel on piling structure in stream, with walkway. Service pole and concrete standpipe on the landward slope. (USACE-1959). This entry matches the Drainage or Irrigation Structure referenced in O&M manual (HLM 5.5).
FS Date: 3/19/2009

View of landwar side--pipe and stand pipe visible.

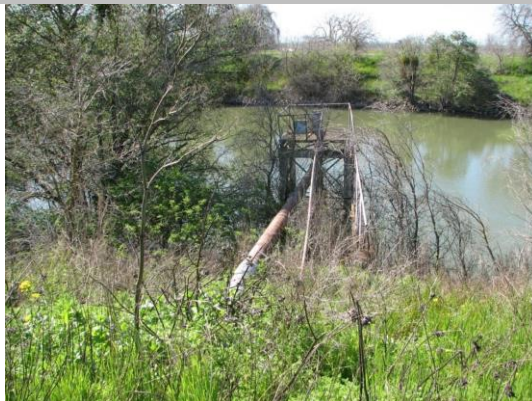
Photo 2 of 2 : UCIP_FA_2016_43433_70483.jpg

View of waterward side--pipe and remaining appurtenances.

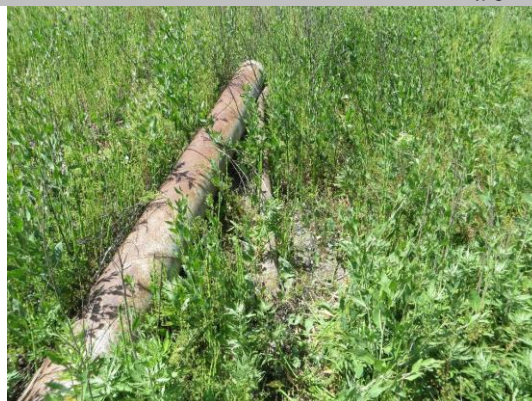
Photo 1 of 2 : UCIP_FA_2016_44391_73749.jpg

LM Start	5.19	Rating **	M	Issue No.	995
LM End	5.19	Issue Type +	En	Location *	CR
Category	Supplemental			GPS Latitude/Longitude	
				Start	End
Item	DWR UCIP Field Study			38.322460 °	38.322460 °
				-121.589690 °	-121.589690 °
DWR ID					
Comment Code					
Inspector Comment					
FS_ID:44391 DS_ID:24189 EP_NO: N/A Repair Type: Non-Urgent Crossing Status: Found UCIP Comments: Appears abandoned and if so should be done so properly. FIELD_STRUCT_DESC: 4-inch pipe through the levee, 3.3 feet below the crown. Gate and pump on platform at the landward toe (missing). Platform on the waterward side. (USACE-1959). This entry matches the Drainage or Irrigation Structure referenced in O&M manual (HLM 5.6). FS Date: 4/9/2015

4-inch pipe next to larger pipe on LS slope.

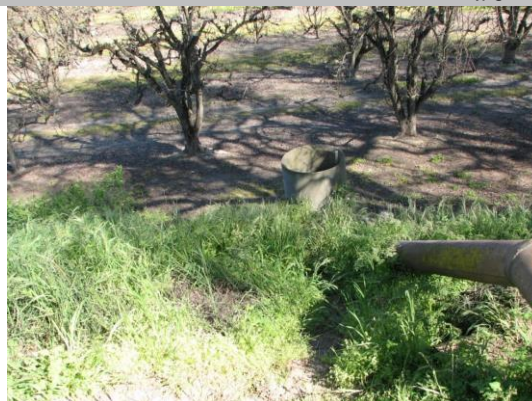
Photo 1 of 2 : UCIP_FA_2016_50016_36841.jpg

FS_ID:50016
DS_ID:24190
EP_NO: 16077
Repair Type: Non-Urgent
Crossing Status: Found
UCIP Comments: 8/22/2016 Crossing has been downgraded from Urgent to Non-Urgent no signs of pipe failure were present on levee crown or slopes during site visit. Need to contact owner to determine last internal inspection completed. (DWR UCIP - omagana)3/19/2009
Soil disturbed on landward slope--need to contact owner. Also vegetation limits the inspector's visibility to identify signs of pipe failure (leaks) along the slope. Recommend removing vegetation along pipe alignment to conduct proper inspection of structure and appurtenances. Note date on photos should be 3/18/09 not 7/26/08 camera metadata is incorrect. (DWR UCIP - omagana)
FIELD_STRUCT_DESC: 10-inch pipe through the levee, 3.8 feet below the crown. Pump in pumphouse on waterside (WS). Service pole on WS slope. Concrete standpipe and distribution box located on the WS toe. Pipe is exposed on both slopes. Section of pipe under crown, between shoulders, removed and replaced with 10-inch steel pipe in November 20, 1991, no permit application was filed. In August 13, 1993, Mr. Steve Makis of Flood Management, revealed that the pipe was not soil proofed, and siphon breaker was not installed, and backfill was less than 90 % and less than 2-foot of cover through the levee crown. Pipe was required to be completely removed and replaced in September 15, 1993. (10-inch authorized under Permit No. 16077, 1993 - John McCormack Company, 10-inch pipe replaces the USACE O&M 10-inch pipe referenced as HLM 5.9) [Additional Reference(s): DWR Levee Log, 2005. USACE San Joaquin O&M Manual Unit No. 110, May 1959, HLM 5.9, Drawing not available].

View of LS--pipe and stand pipe visible.

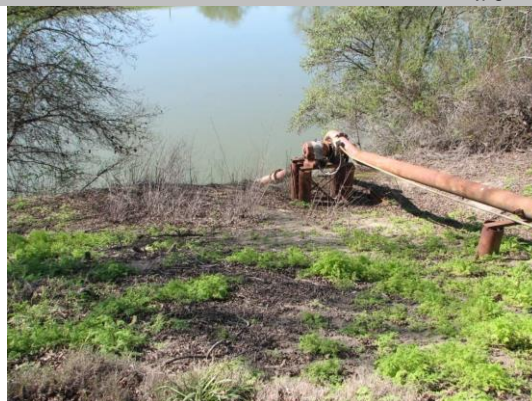
Photo 2 of 2 : UCIP_FA_2016_50016_36843.jpg

FS_ID:50016
DS_ID:24190
EP_NO: 16077
Repair Type: Non-Urgent
Crossing Status: Found
UCIP Comments: 8/22/2016 Crossing has been downgraded from Urgent to Non-Urgent no signs of pipe failure were present on levee crown or slopes during site visit. Need to contact owner to determine last internal inspection completed. (DWR UCIP - omagana)3/19/2009
Soil disturbed on landward slope--need to contact owner. Also vegetation limits the inspector's visibility to identify signs of pipe failure (leaks) along the slope. Recommend removing vegetation along pipe alignment to conduct proper inspection of structure and appurtenances. Note date on photos should be 3/18/09 not 7/26/08 camera metadata is incorrect. (DWR UCIP - omagana)
FIELD_STRUCT_DESC: 10-inch pipe through the levee, 3.8 feet below the crown. Pump in pumphouse on waterside (WS). Service pole on WS slope. Concrete standpipe and distribution box located on the WS toe. Pipe is exposed on both slopes. Section of pipe under crown, between shoulders, removed and replaced with 10-inch steel pipe in November 20, 1991, no permit application was filed. In August 13, 1993, Mr. Steve Makis of Flood Management, revealed that the pipe was not soil proofed, and siphon breaker was not installed, and backfill was less than 90 % and less than 2-foot of cover through the levee crown. Pipe was required to be completely removed and replaced in September 15, 1993. (10-inch authorized under Permit No. 16077, 1993 - John McCormack Company, 10-inch pipe replaces the USACE O&M 10-inch pipe referenced as HLM 5.9) [Additional Reference(s): DWR Levee Log, 2005. USACE San Joaquin O&M Manual Unit No. 110, May 1959, HLM 5.9, Drawing not available].

View of pipe and pump along WS slope.
